## Find Condenser Tube Leaks with Ultrasound

By Allan Rienstra, SDT Ultrasound Solutions

### Case Study – AB Brown Power Plant, Mt. Vernon, Indiana

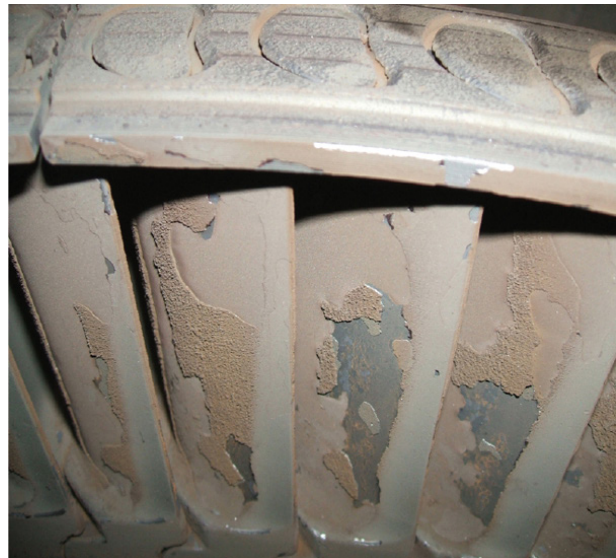
Figure 2 - Scaling Creates Vibration and Imbalance

Formations on turbine blades, pump vanes and valves diminishes their efficiency, creates imbalance, and forces drive components to work harder just to maintain output.

Increased vibration levels accelerate component deterioration. Originally, tube leaks were caused by corrosion. Add in the juddering and jarring from vibration and new leaks appear in the form of cracked tubes.

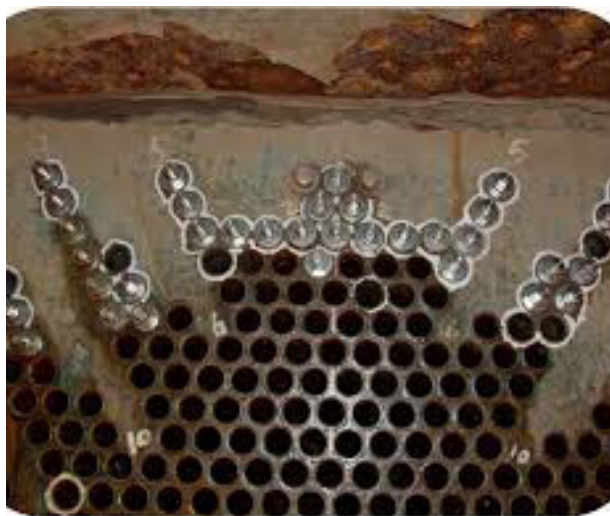
Figure 3 - Leaking Tubes are Plugged Out of Service

The other action choice is to identify the leaking tubes and plug them; effectively removing the leakers from service. This is the better solution because it treats the cause. But it too carries a downside.

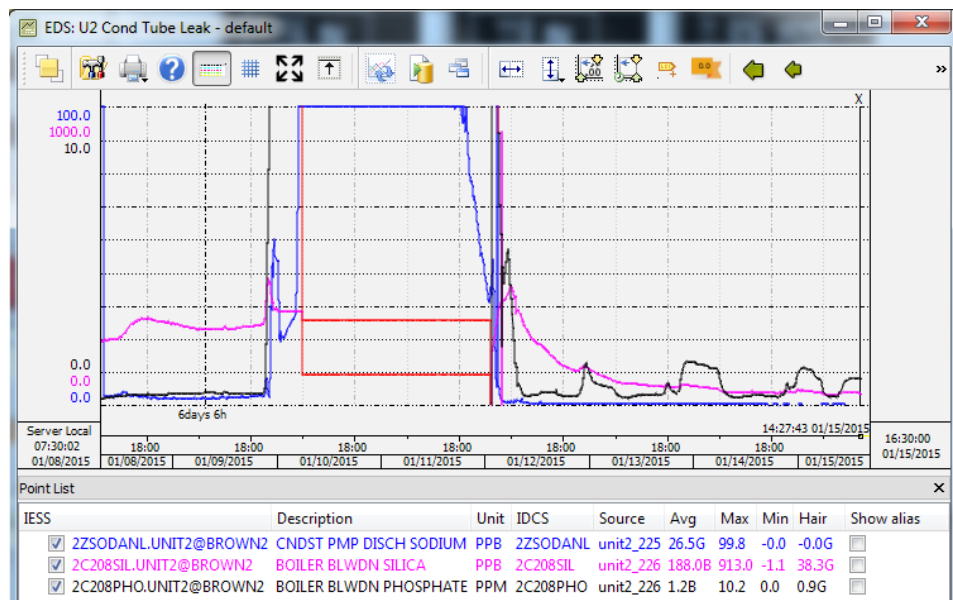
Figure 6 - Spike above 1000ppb in Unit 2 is a leak that needs immediate attention

Meanwhile, sensors also indicated high levels of sodium and silica in Unit 2. With valves they isolated and drained the half of the condenser with the leak. See the next graphic.

They knew they had a tube leak in Unit 2's condenser. During a planned outage they did a dye hydro on it to locate the tube leak. This graph of Unit 2 shows the difference in the silica and the sodium when a tube leak is present. Disregard the area between 1/9 and 1/12 as this was the area

that the Unit was offline and the condenser tube side was filled with water and dye. Just look at the

difference in the “pink” (Silica) amplitude before and after.

A significant tube leak on Unit 2 caused reduction in output. The Unit was shut down on 1/10 and 1/11 for a dye test. Leaks were found and isolated. Silica levels restored to normal by 1/13 and 1/14.

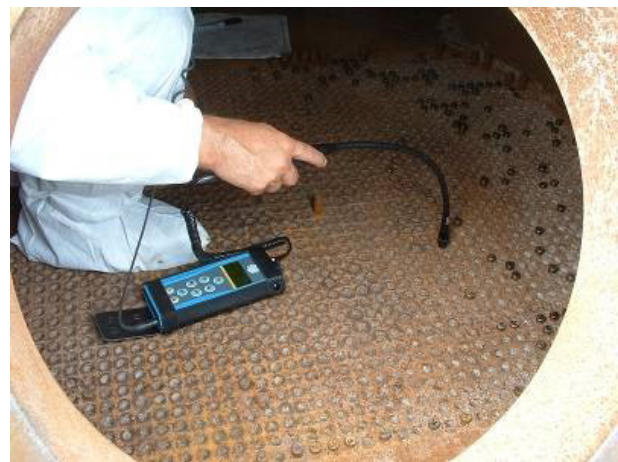
Figure 7 - Finding Tube Leaks with SDT Ultrasound

“Once the two tubes were identified – the Results Engineer took the SDT270 Unit into the Condenser. He started in an area that the helium had not identified a leak. He did not use the precision tip but just “scanned” the area. He said he heard nothing in the areas where the helium had not

detected a leak. However when he waived the SDT270’s airborne sensor in the area where the tube leaks were known to exist, he started hearing noise. As he continued scanning over the tubes that were leaking he could hear a “pssst” then nothing as he moved away from the tube. He then put the precision tip on and started checking each individual tube in about a 5 tube by 5 tube area. He said when he checked the leaking tubes – he actually had to turn the sensitivity down on the SDT Unit.”

“In all – he scanned approximately 18,000 tubes in 30 minutes with the SDT270 compared to a whole day with Helium Tracer Gas. The SDT270 Unit narrowed the leak(s) down to a small area.”

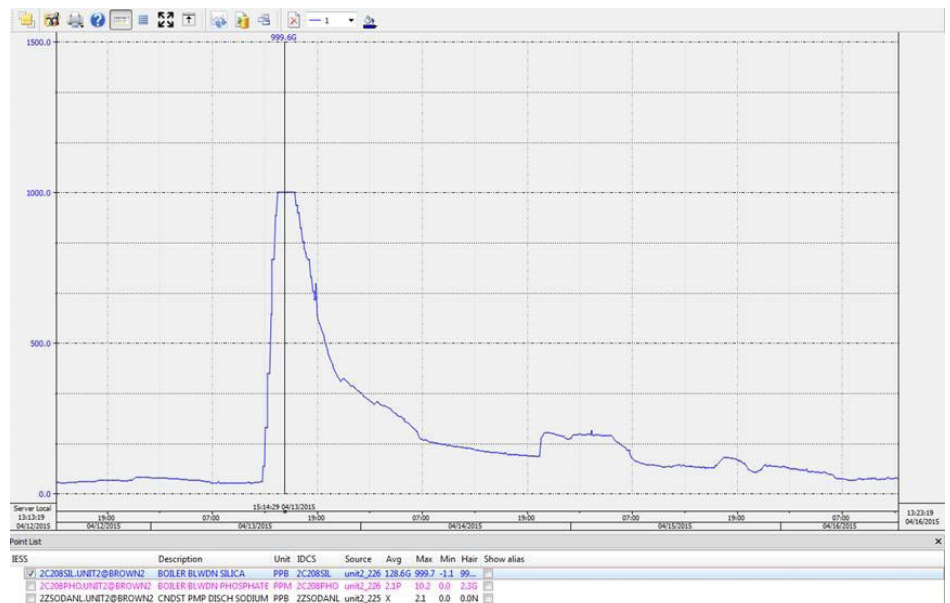
Figure 9 - Blowdown silica spiked to 1000ppb; 39 tubes were plugged from service

Silica levels spiked in the cooling tower blowdown water at 3:15pm. Looking at the graphic below, the control room was alerted when blowdown silica spiked to 1000 ppb (parts per billion).

This graphic points out the source of the spike too. Unit2\_226 tells them which side of the condenser to valve out. The turbine can keep running, albeit at reduced capacity, while the ultrasound team heads in to find the leak.

The SDT270 ultrasound equipment was used to rapidly identify the tubes and the area. The leak was massive and required the plugging of 39 tubes. As a secondary check, and to follow procedure, the leaking tubes were then verified with Helium.
